Meridian Hill Park Cultural Landscape Report Vol. 1

National Park Service - National Capital Region
Contract #: 1443X300094034
architrave, p.c. architects, Washington, D.C

31 August 2001

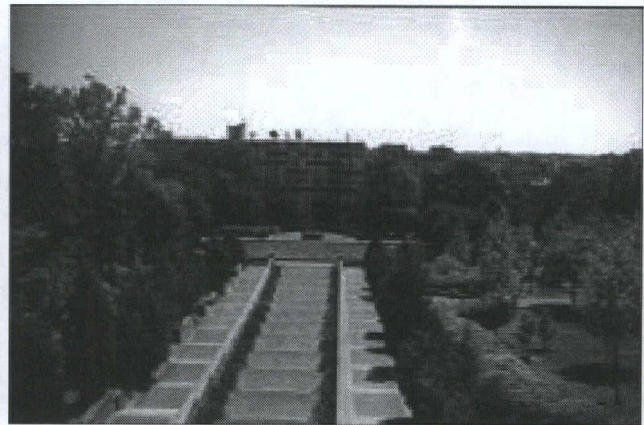
Figure 94: 1997 view south along the cascades. Note apartment building intruding on the historic view of Washington (Land Ethics, Inc.).

The view along the main park axis to the north has changed due to the construction of an apartment building to the north of the park off Euclid Street (see figure 96). While historically the view was of a varied skyline, it is now commanded and overshadowed by the apartment complex.

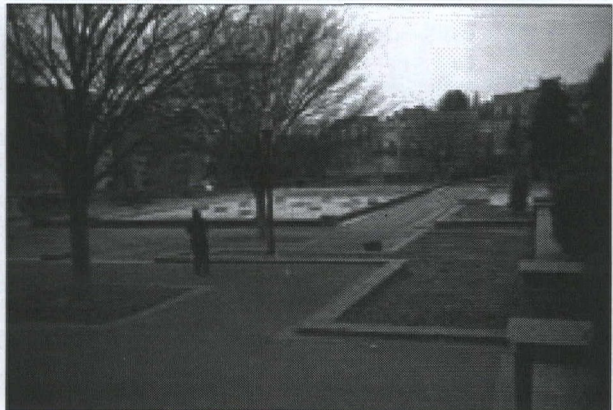
Figure 102: View across the lower plaza from the Buchanan statue, 1997, (Land Ethics, Inc.).

Changes in the spatial character, views and circulation of the lower plaza have been confined to the views and vistas, and the quality of the spatial enclosure. The entrance from 16th Street continues to serve as the major access point to the lower plaza through the lower park (see figures 99, 100 and 101). The spatial quality of this area as an enclosed room has been lost due to loss of enframing plant materials, mainly the formal, clipped American Hornbeam hedges, which used to surround the lower plaza. The loss of informal plantings between the plaza and W Street and in the hillside gardens has also caused the lower plaza to feel much more open and exposed than it did after construction (see figures 102 and 103).

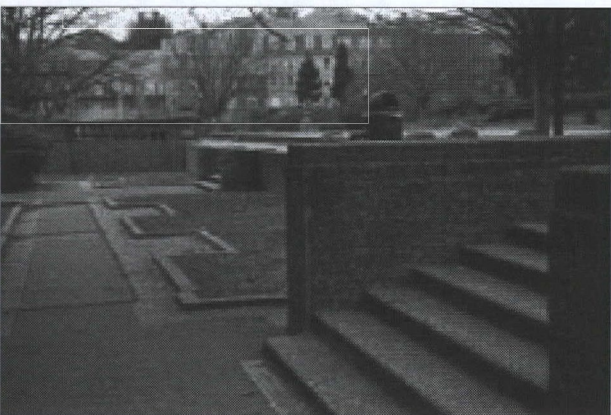
Figure 103: Area between the lower plaza and W Street at the 15th Street entrance, looking west to the exedra, 1997. Note the recesses of paving into planting areas intended to receive benches that were never installed. (Land Ethics, Inc.).

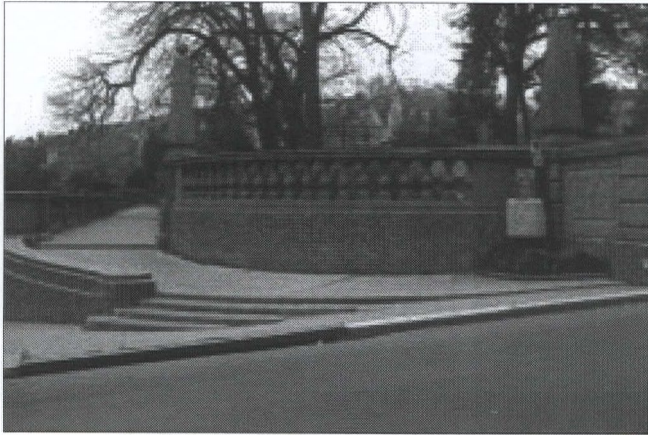
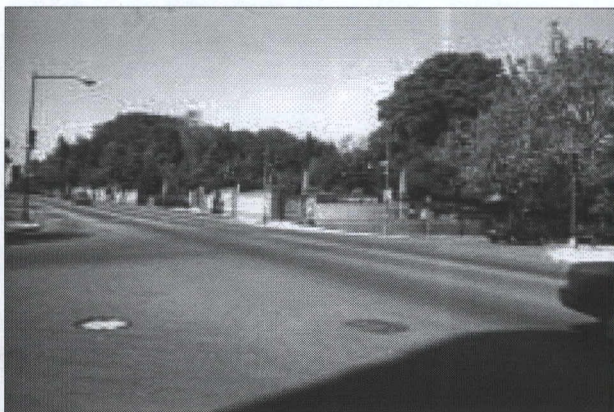
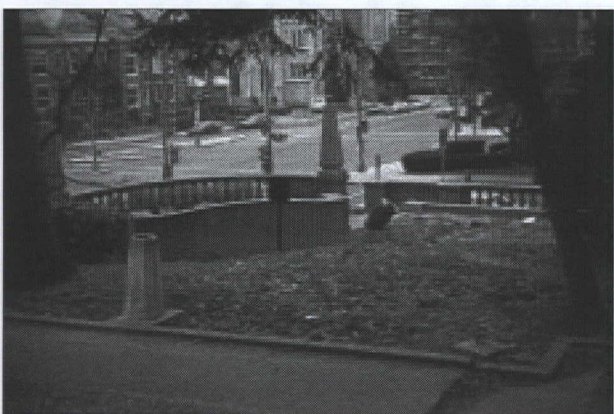
Entrances to the park from the corners of 16th and W and 15th and W Streets (see figures 104, 106, and 110) have retained their form and character with the exception of the loss of enframing plant materials.

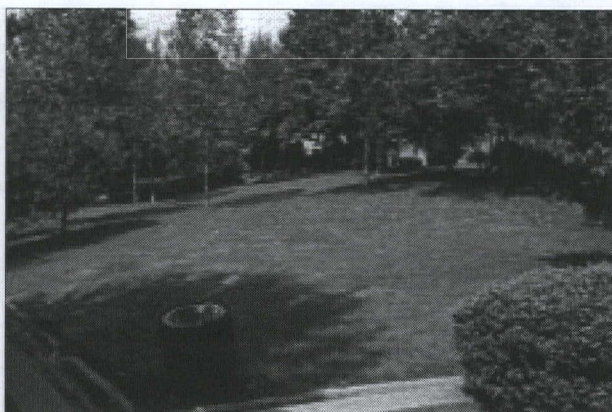
Figure 107: 1996 view from Dante northwest across hillside gardens (Land Ethics, Inc.).

The hillside gardens and cascades have generally retained their spatial quality and character. Only three of the original sycamores planted in the hillside gardens have survived. The rest have been replaced with a disease-resistant improved variety, which will take time to mature. The English Ivy (*Hedera helix*) originally planted as a ground cover under the sycamores has been replaced by grass. Thus, these areas have changed subtly in circulation and use, from areas that visitors merely looked into, to areas that they can access and move through (see figure 107).

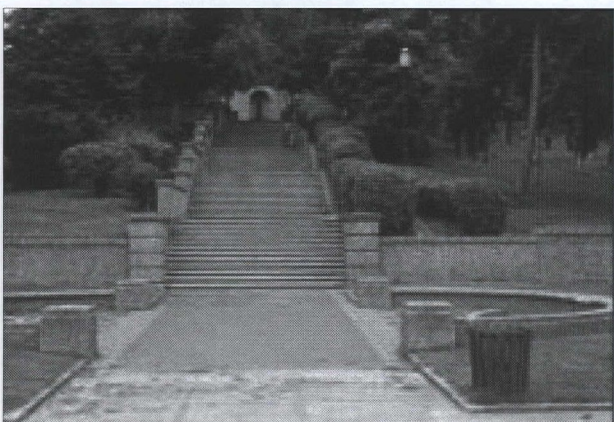
Figure 108: View north up the west ascent from the lower plaza, 1997, (Land Ethics, Inc.).

The hillside ascents to the west (see figure 108) and east (see figure 82) have retained their use as secondary circulation routes, connected to the east-west pathways that join the ascents to the cascades (see figures 105 and 109). Again, changes to the spatial quality in these areas are primarily due to the loss of enframing plantings on either side of the walkways.

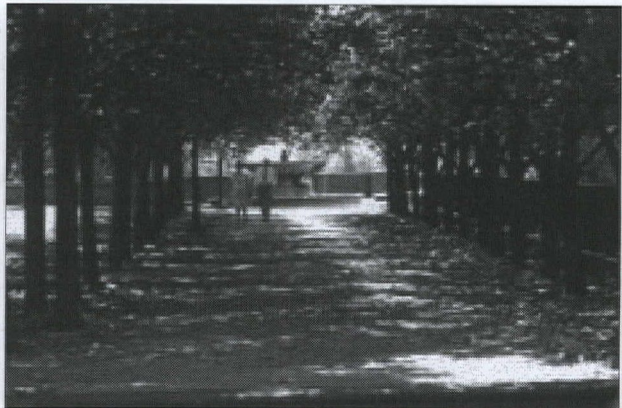
Figure 113: 1996 view along linden alley looking south to the great terrace. Note the benches missing from both sides of the alley (Land Ethics, Inc.).

Access to the great terrace has continued to be from the east and west staircases from the hillside gardens (see figure 92), through the linden allee from the 16th Street entrance (see figure 113), or directly from the mall. The major changes to this area of the park have not occurred to the spatial organization or circulation, but to the commanding view of Washington to the south. The views (see figures 86, 88, 90, and 94), which were historically more expansive and included the Capitol and the Washington Monument, were blocked by the construction of the Meridian Towers apartment building south of the park in 1964.

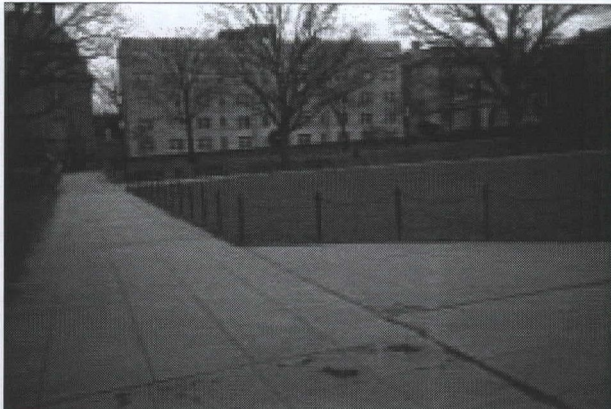
Figure 114: 1997 view along the north cross axis of the park between 15th and 16th Streets. Note triangular paving insert in corner and posts and chains installed to control traffic. (Land Ethics, Inc.).

A secondary circulation and vegetation issue has to do with the wearing of informal paths across the grass panels of the mall and the tendency of service vehicles to drive on the grass panels, both damaging the grass and often breaking quick couplers. Dirt paths have also been worn between the informal walks and the main mall walks in various locations. The park has attempted to discourage the pedestrian path across the mall with posts and chains, with little success, although the posts appear to have discouraged the service vehicles. In addition, at the north end of the mall, triangular paving sections and more posts and chains have been added, responding to the tendency to cut across corners (see figure 114).

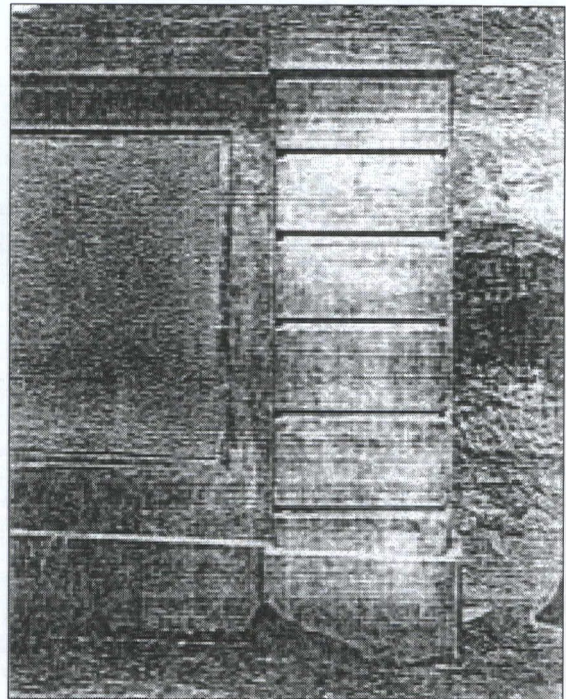
Figure 124: Photograph of one of the early rejected test panels, showing the pebble-dash finish in the center panel and the vertical scoring on the pier to simulate tool marks on stone. (RCP-CRF, dated 7-13-1?, the last number of the date missing).

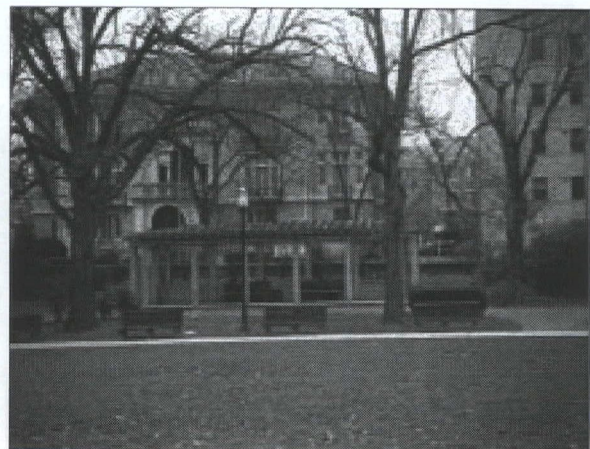
While the pavilion is in good condition with new roof timbers installed in 1993, the overall structure little resembles the structure in place at completion of the park in 1936.

Figure 127: The pavilion, 1996 (Land Ethics, Inc.).

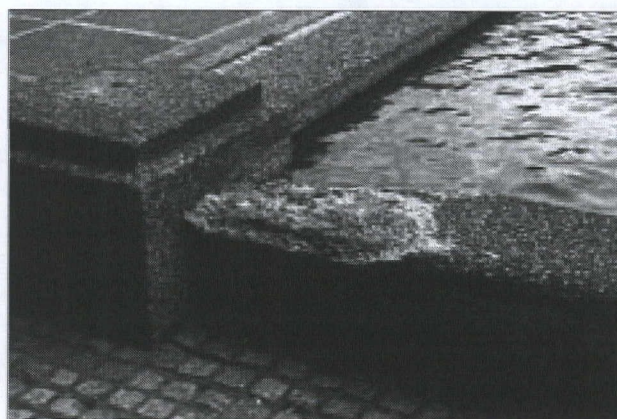
Figure 150: Deteriorated wall cap at the northwest corner of the reflecting pool, 1997, (Land Ethics, Inc.).

The reflecting pool is in fair condition. Some of the pool's expansion joints leak. Many of the recessed lights cast into the wall of the pool also leak, especially when the water level in the pool is at or above its designed level. Segments of the reflecting pool containing wall are badly damaged with reinforcing exposed (see figure 150 and plan sheet 38). Of eight original spray jets in the reflecting pool, only four remain; one in each corner. It is not known when the other four jets were removed, although no historical photographs after 1939 show eight in operation.

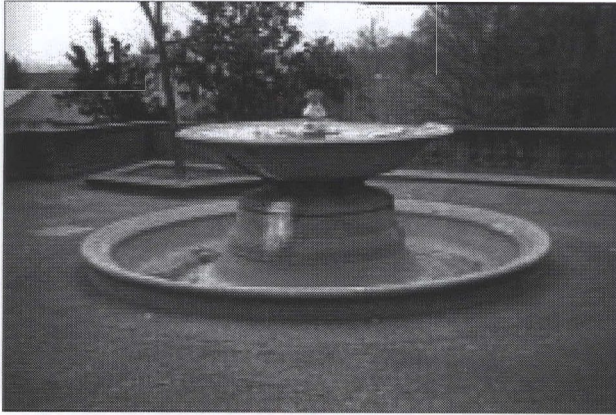
Figure 151: Efflorescence or mineral deposits on the west fountain on the great terrace 1997, (Land Ethics, Inc.).

The two large fountains on the great terrace are both operational. However, the west fountain is badly damaged on one side, with a large section of the lip of the upper basin missing and with heavy efflorescence (see figures 151 and 152, and plan sheet 39). This fountain will continue to deteriorate as water flows over the lip. The fountain on the east side of the great terrace is intact and in better condition. Both fountains on the great terrace suffer from uneven settling of their bases. The result is that the basins on both fountains are slightly tilted, causing the water to flow unevenly over their edges.

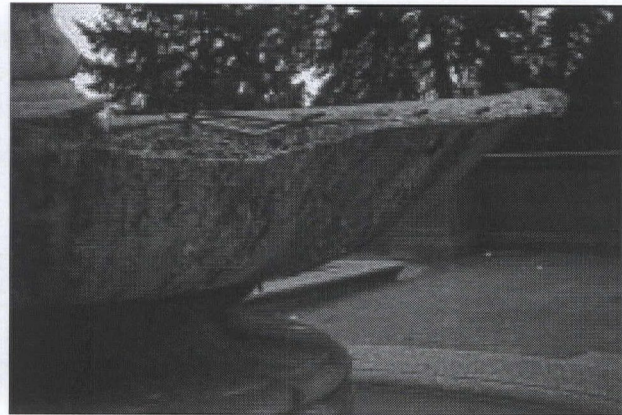
Figure 152: Missing exposed aggregate concrete, 1997, on the fountain lip, (Land Ethics, Inc.).

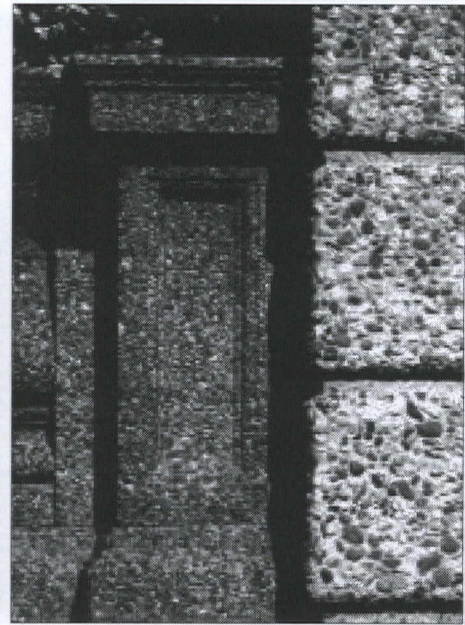
Figure 160: Exposed aggregate was used in various sizes. The work to the right in the photograph is unusually varied for the park and may be either replacement concrete or early in the park's construction before perfection of the construction techniques, 1996, see plan sheet 28 (Land Ethics, Inc.).

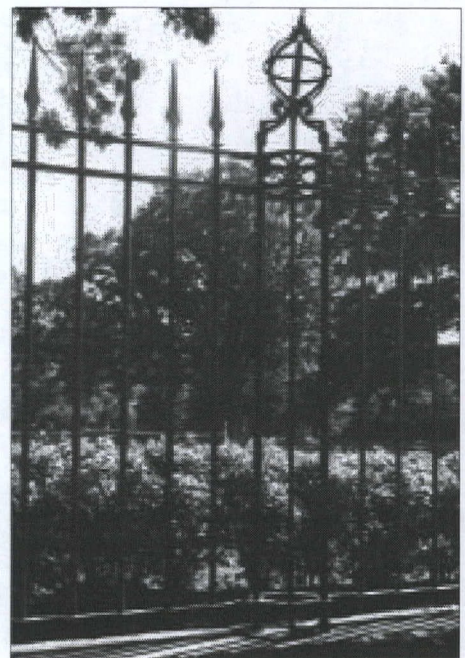
Figure 161: Globe-shaped finials on the iron fence at the northern boundary of the park on Euclid Street, 1997, see plan sheet 28 (Land Ethics, Inc.).

The existing fencing in the park, along Euclid Street and around the play area in the northeast corner is in generally good condition. However, several finials and points on the Euclid Street fence are either missing or require repair. The base of the fence has some areas of serious corrosion. The fence at the play area is missing some of its decorative elements and a number of its finials. The metal fence behind the benches lining the linden allee is missing altogether. It was removed in conjunction with the 1982 repairs in that area and never replaced.

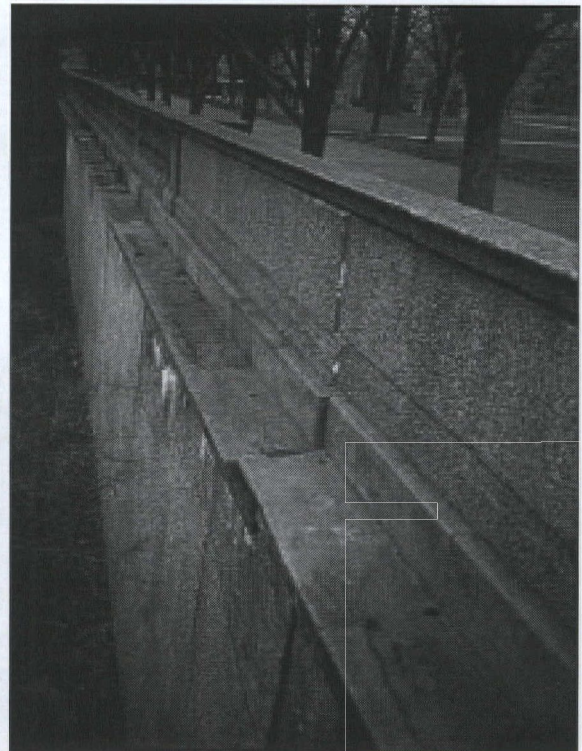
In 1982 a major project was undertaken to stabilize this wall by installing additional deadman ties from the back of the wall under the linden allee. It appears that either movement is still continuing at the southernmost end of this wall where it meets the great terrace, or that it is a section not repaired in the 1982 contract (see figures 169 and 174). Because the exposed aggregate concrete panels are separately cast and mounted on the face of the structural retaining wall, this apparent movement could result in a catastrophic failure of attachment between the two. These areas should be examined and monitored for causes and remedies.

Figure 169: The high 16th Street retaining wall at the linden allee, 1997, (see plan sheet 28) showing location of possible continuing movement. See also figure 174 (Land Ethics, Inc.).

The high 16th Street retaining wall has for many years been separated at the expansion joints, causing large sections of the wall to deflect (see figure 169). A 1982 NPS project added dead-man tie-backs. Today, broad sections of the wall have efflorescence and spalling.

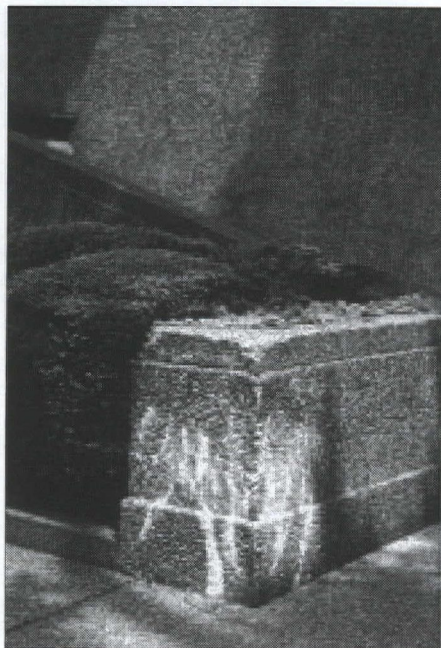
Figure 171: Efflorescence on the planting pocket at the base of the great wall below the great terrace, see plan sheet 28, 1997 (Land Ethics, Inc.).

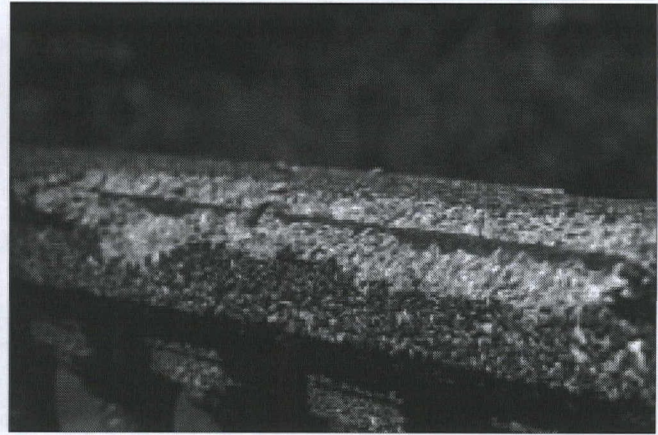
Sections of balustrade and rail coping at the overlook above the 16th Street entrance are badly damaged with deteriorated sections of balustrade, leaving the reinforcing exposed (see figure 174 and plan sheet 40 Existing Conditions 3, for the detailed locations of deteriorated balustrades and coping). A section of baluster, a console, and two urns are missing altogether from the lower retaining wall below the 16th Street overlook.

Figure 174: Section of top rail above the 16th Street entrance deteriorated with exposed reinforcing steel, 1997, see plan sheet 28 (Land Ethics, Inc.).

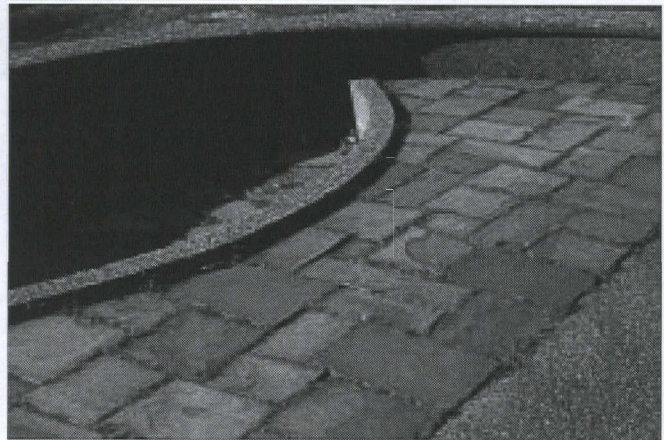
Figure 175: The sandbox bottoms and the areas between them and the adjacent walks, originally sand and gravel respectively, are now paved with red and blue non-original flagstones, 1997 (Land Ethics, Inc.).

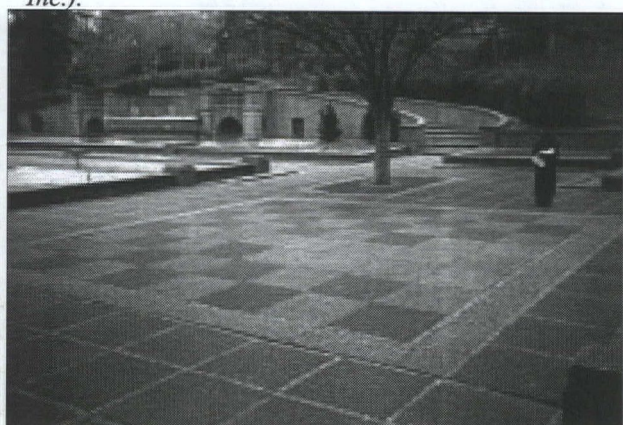
Figure 184: A life-size chess board formed with exposed aggregate pavement at the east side of the lower plaza, 1997, see plan sheet 30. Some of the panels are replacement panels (Land Ethics, Inc.).

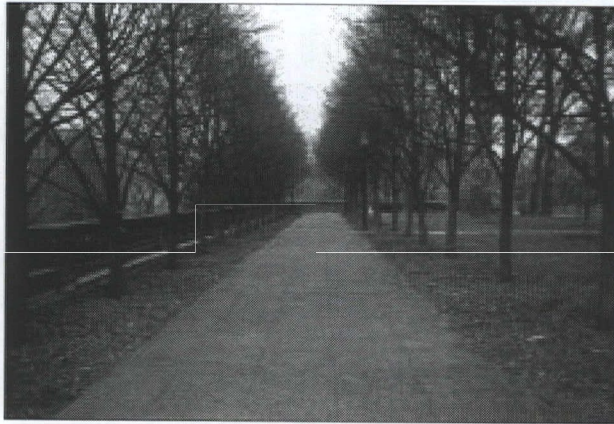
Figure 192: The linden alley has original exposed aggregate pavement in good condition, with stripes of replacement paving at locations of 1982 tie-back project, 1997, see plan sheet 32 (Land Ethics, Inc.).

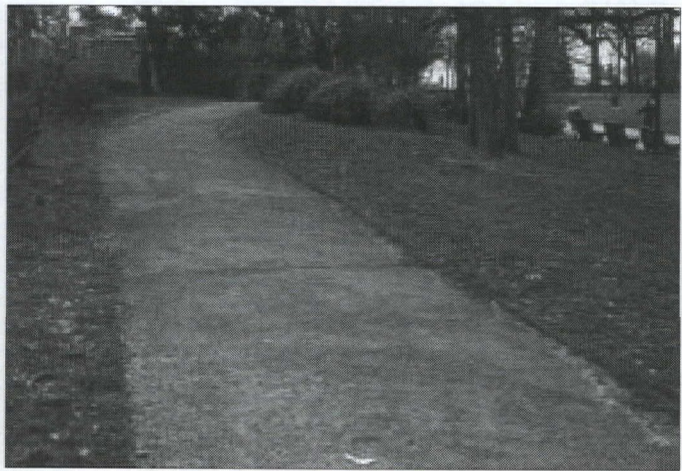
Figure 200: Asphalt walk in the informal gardens on the east side of the mall, 1997, see plan sheet 34 (Land Ethics, Inc.).

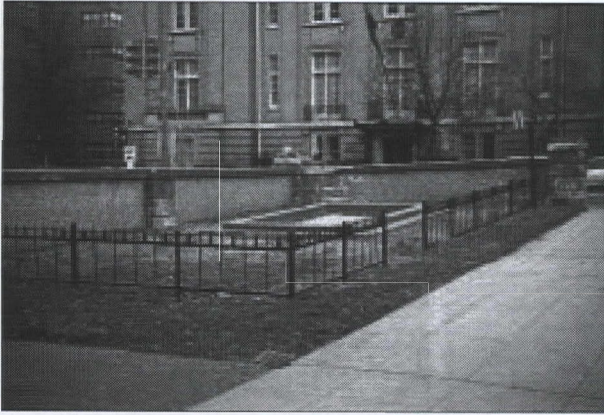
Figure 202: The original paved walkway (visible at the lower left of the image above) leading from the wall niche next to the play area at the northeast corner of the park is constructed of crushed black trap with beige exposed aggregate and contrasts with the smooth concrete non-original walkways of the upper mall, 1997, see plan 34 (Land Ethics, Inc.)

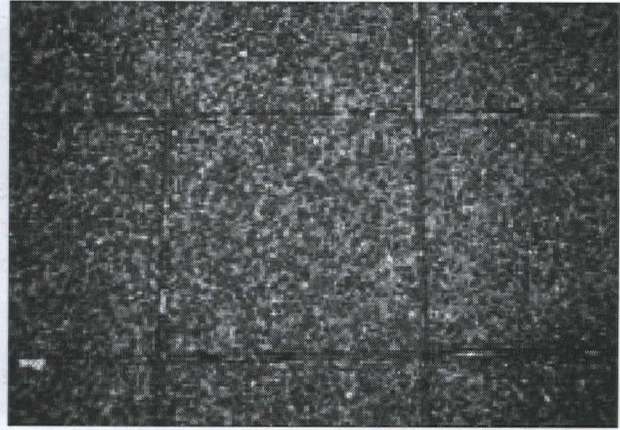
Figure 203: Original pavement walkways on the mall are crushed black trap with 5-10% beige, 1997, see plan sheet 33 (Land Ethics, Inc.).

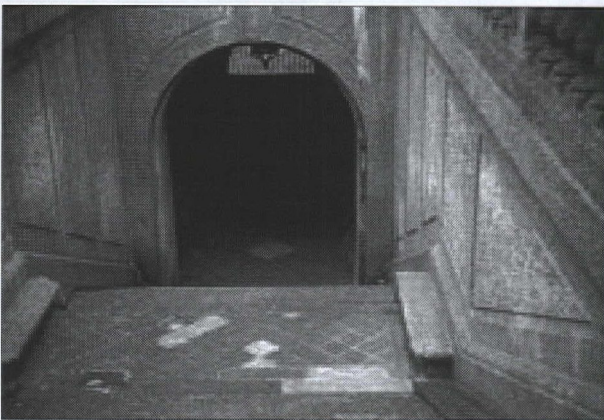
Figure 204: Stairs and landing leading from the 16th Street main entrance of black trap. Replacement paving is clearly visible in picture, 1997, see plan sheet 33 (Land Ethics, Inc.).

Other repaving and repair work in the upper park is fairly obvious. Individual steps were replaced in the flight from 16th Street to the northern end of the Linden Allee and are significantly lighter in color than the original ones of crushed black trap. Stripes of original paving in the Linden Allee were removed for the tie-back project and replaced. Most of these have settled and are slightly different from the adjacent paving.

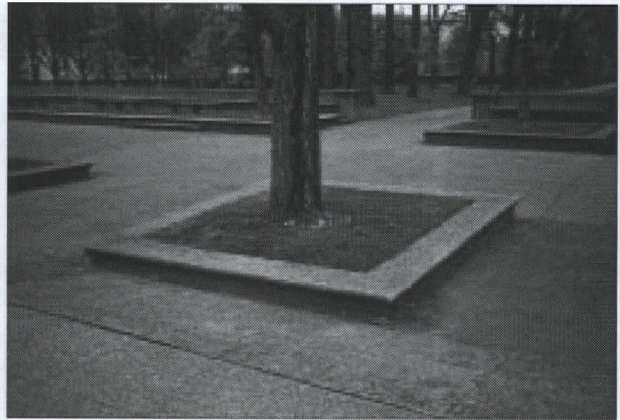
Figure 205: Settlement has caused the pavement on the great terrace to become uneven in many areas, 1997, see plan sheet 32 (Land Ethics, Inc.).

Major subsurface settling has caused the pavement on the great terrace to become uneven and badly damaged in many areas (see plan sheet 39). These conditions have been documented in correspondence contained in the National Archives, the Cultural Resource files of the National Park Service, and site condition-engineering reports. Uneven settlement of the great terrace has caused many of the storm drains to become either obstructed and/or out of grade so as to serve no useful function. This has resulted in areas of standing water on the exposed aggregate surface of the terrace, contributing to the deterioration.

This settlement was referred to by Peaslee in correspondence in the 1930's and may have been a result of original construction. The great terrace paving has been replaced in whole or

part, replacing damaged paving but not remedying the settlement. Thus, the abrupt tilts and angles caused by differential settlement still exist, but have been paved to connect high and low points. That replacement paving is now deteriorated creating new tripping hazards. The abrupt grade changes are also a serious impediment for those using mobility aids.

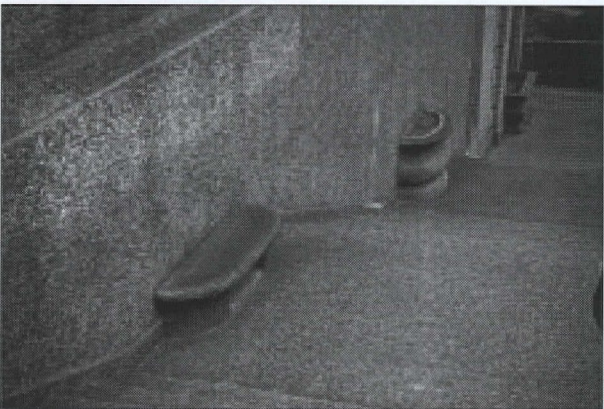
Figure 206: Stairs descending from the great terrace are constructed with beige pebble exposed aggregate, 1997, see plan sheet 32 (Land Ethics, Inc.).

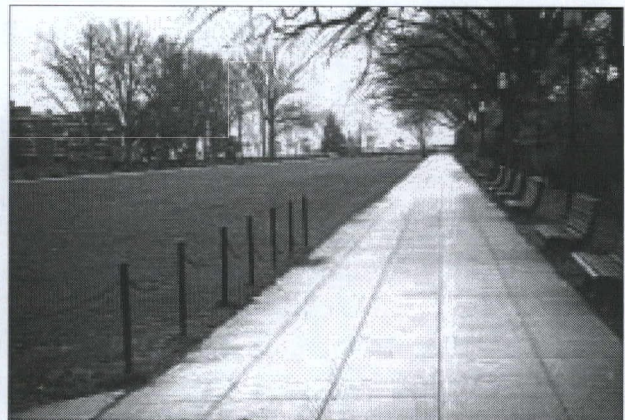
Figure 207: Smooth concrete walkways flanking the mall are replacement paving. Posts and chains were installed well after completion of the park to limit informal paths and cutting across corners, 1997, see plan sheet 34 (Land Ethics, Inc.).

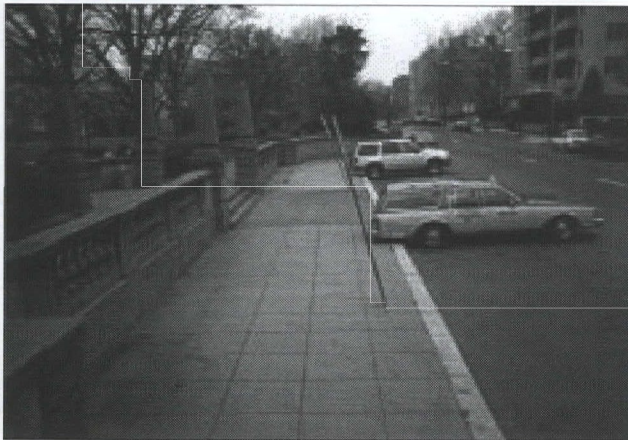
Figure 208: Smooth concrete with grid scoring at the 15th Street entrance. Note segment of entrance that has been resurfaced with exposed aggregate of crushed black trap, 1997, see plan sheet 33 (Land Ethics, Inc.).

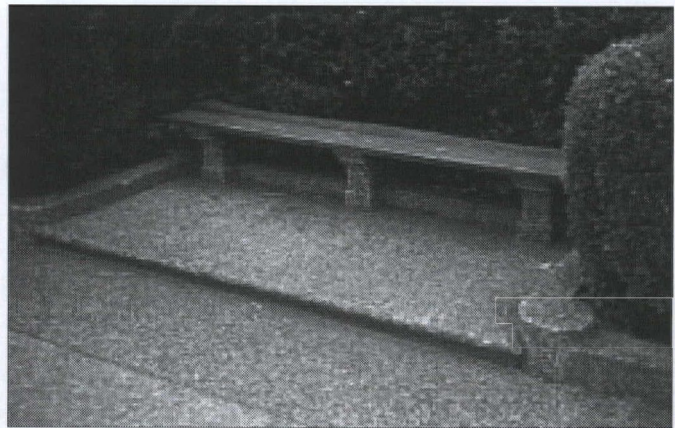
Figure 214: One of the six small backless wood slat benches on the cross walk at the base of the great wall, 1997, see plan sheet 35. Note that the original narrow slats have been replaced with wide boards at this bench (Land Ethics, Inc.).

Many of the wood slats in place in the park today are obviously not original. None of the edges are eased or have radius profiles. Some of the shallow free-standing benches now have only a few wide boards instead of a number of 3" slats. Some of the deeper back-less benches have been flattened when slats were replaced, rather than recreating the contoured profile visible in figure 217. Only a few slats are missing throughout the park at any given time and while plastic replacement slats were apparently used at one time, such is not currently the case.

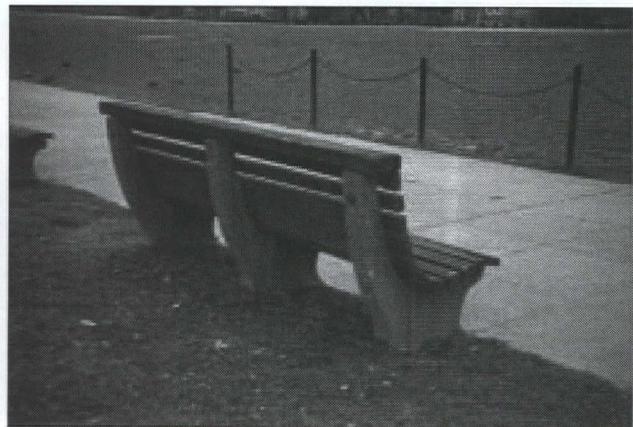
Figure 221: Benches along the mall walkways, 1997, see plan sheet 35 (Land Ethics, Inc.).

One intermediate exposed aggregate concrete support is missing from one of the mall benches (see plan sheet 35). Otherwise, all the original concrete supports are in place. Some of the drain holes at some of the molded concrete seats are clogged.

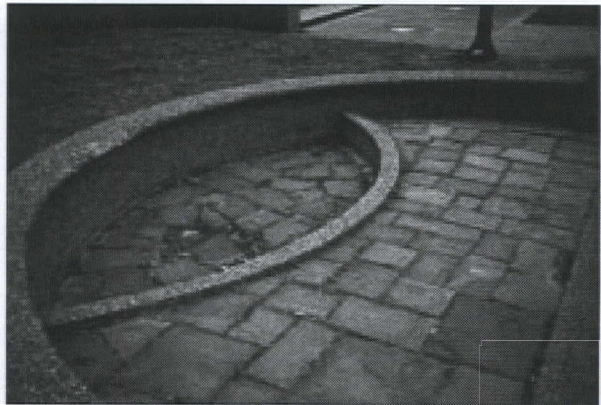
Figure 224: Detail of Play Area #2 at the west end of the lower plaza, 1997. The gravel originally shown on the upper level as well as the sand area itself, are both paved in non-original vari-colored flagstone (Land Ethics, Inc.).

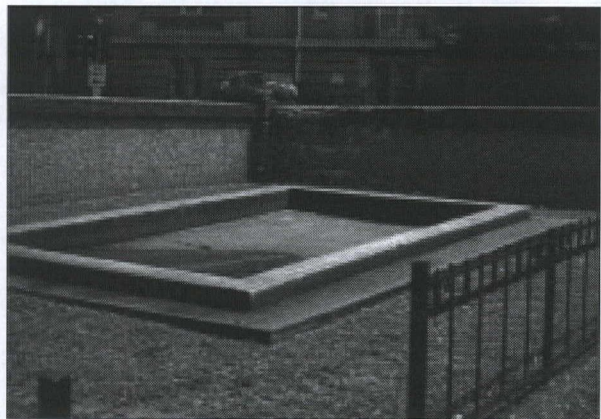
Figure 225: A rectangular play area and sand box [Play Area #1] at the northeast corner of the park, 1997, (Land Ethics, Inc.).

Play Area #1 - This site is in a state of disrepair. The brick pavement is overgrown with grass and the sandbox no longer contains sand. The sand box weep holes are clogged, and the concrete sand box itself is cracked. All of the European linden trees are missing as are the Creeping Euonymus and Japanese Creeper on the surrounding exposed aggregate walls. The 30" tall iron fence is present although missing most of its finials.

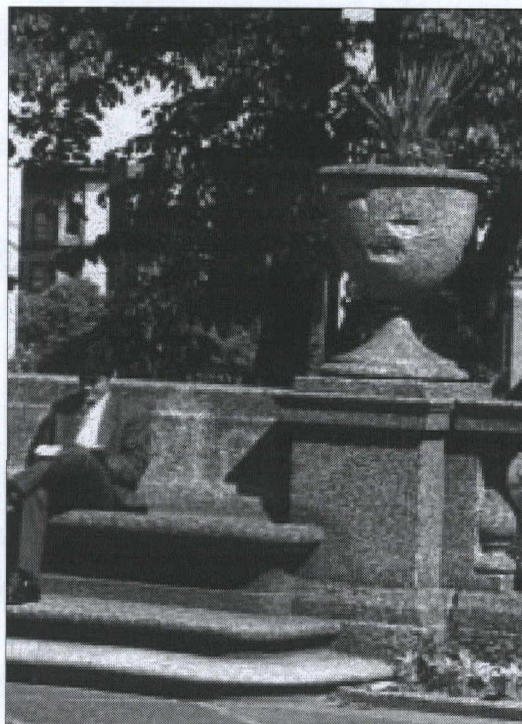
Figure 228: Planting urn at the exedra, 1997, (Land Ethics, Inc.).

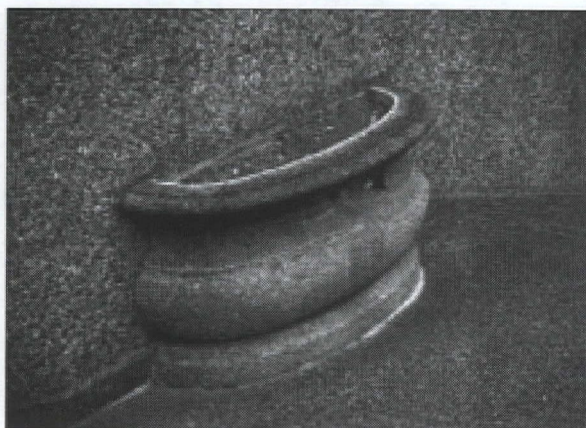
Figure 229: One of the planters located on landings of stairs descending the great wall. Note the recessed light fixture cast below the planter's lip. 1997, (Land Ethics, Inc.).

The two crescent-shaped decorative planters located along the stairs from the great terrace are both in good condition with the exception of the recessed light fixtures, which are damaged. It does not appear that any formal plantings have been placed in these two planters.

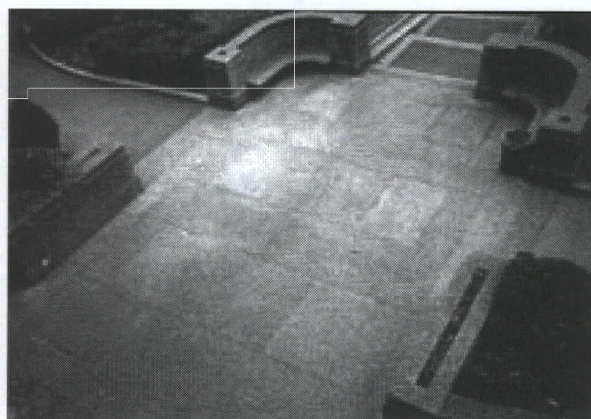
Figure 230: Narrow planting pockets were cast into walls at the upper terminus of both the east and west ascents, 1997, (Land Ethics, Inc.).

The narrow planting pockets cast into the low exposed aggregate retaining walls at the upper terminus of the east and west as-

cents are all basically in good condition, although it is not known if water is seeping into the interior of the walls. In some areas, there are signs of moisture seepage and efflorescence on the wall surfaces, particularly on the walls below the planting pockets at the east landing below the great wall (see plan sheet 39 Existing Conditions 2). Whereas some segments of these pockets contain plantings, such as yucca, others collect debris.

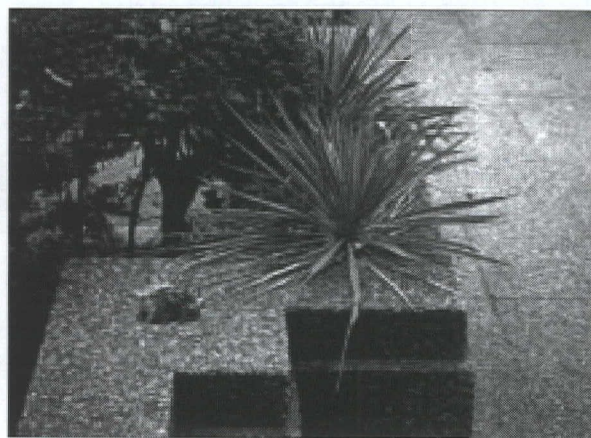
Figure 231: Detail of planting pockets located in exposed aggregate walls in the hillside gardens and cascades area, 1997, (Land Ethics, Inc.).

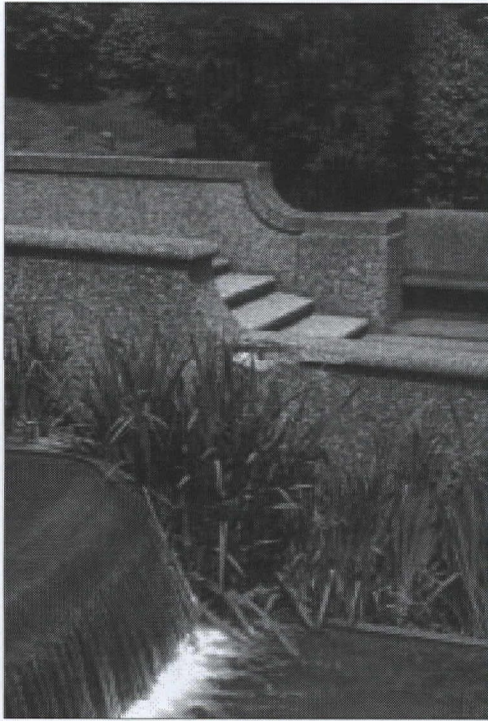
Figure 232: Planting pockets are located on either side of the cascades, 1997, (Land Ethics, Inc.).

The linear planting pockets that line the cascades appear to be in good condition, although numerous sections of retaining wall above these pockets have spalled or broken and have efflorescence (see plan sheets 38-39 Existing Conditions 1-2). Apparently these pockets leak as water from the cascades stands in them.

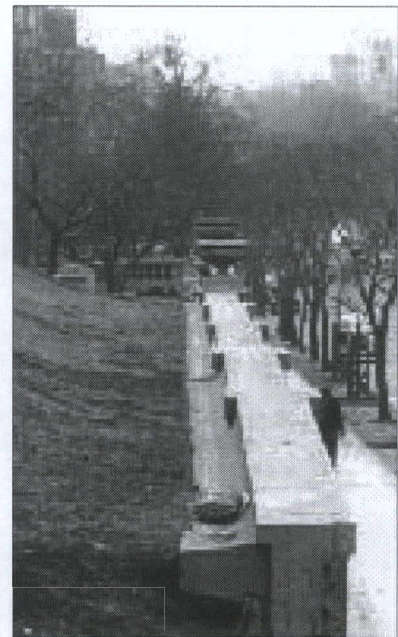
Several of the urns are missing, notably two on the 16th Street retaining wall below the overlook, as well as the balustrade section between them.

Figure 234: Planting urns, visible above on the 16th Street retaining wall below overlook are missing today (RCP-CRF, c. March 16, 1936).

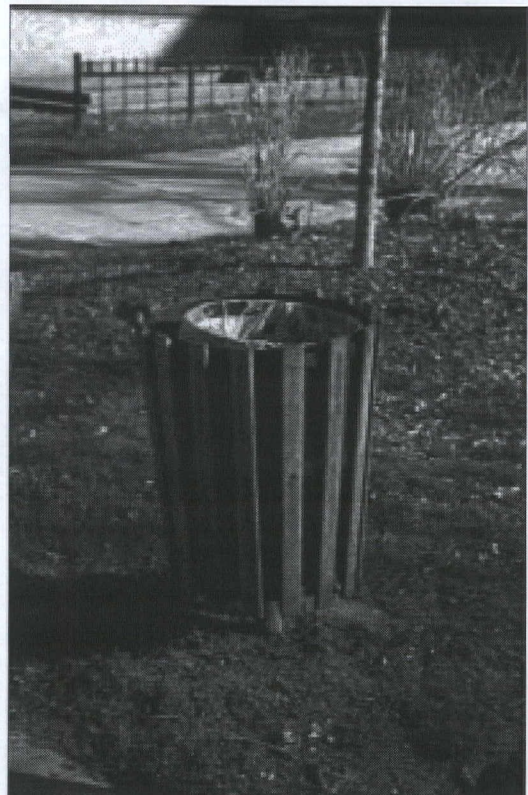
Figure 237: National Park Service tulip-style trash receptacles are located throughout the park today, 1997 (Land Ethics, Inc.).

No original trash receptacles remain and replacement units are in a general state of disrepair. In some instances, the only remaining portion of the tulip-type trash receptacle is the pedestal post and bottom ring of the receptacle. The remain-

der of the receptacle has either been broken or burned. It is also common to find the tulip-type receptacle sitting directly on the ground with no pedestal remaining. Many of the metal cans are badly dented and scratched. See plan sheets 38-41 for identification of damaged receptacles and plan sheet 45 for locations of trash receptacles.

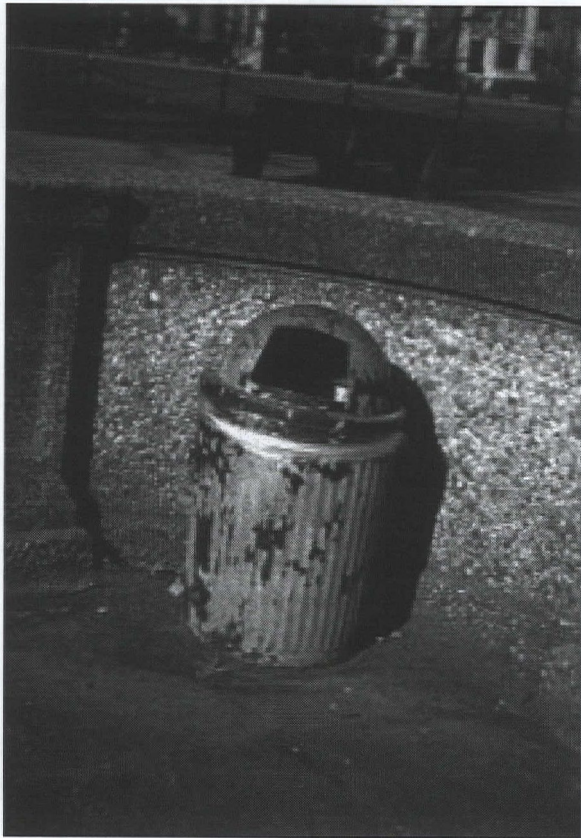
Figure 238: Metal trash cans are used throughout the park today, 1997, (Land Ethics, Inc.).

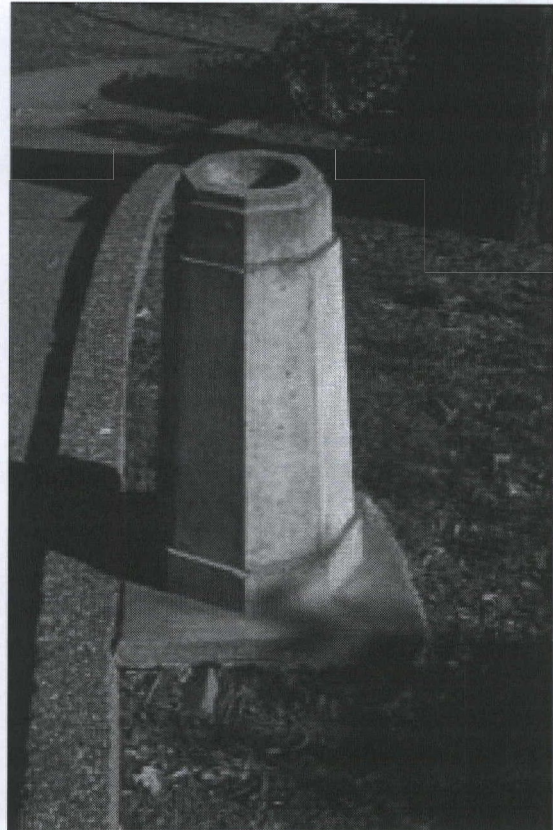
Figure 242: National Park Service pedestal style fountains, developed for use as a standard in the early years of the National Capital Parks, have replaced original units, 1997 (Land Ethics, Inc.).

The replacement drinking fountains are all fully operational although many suffer from broken foundations and other aesthetic defects (see plan sheets 38-41).

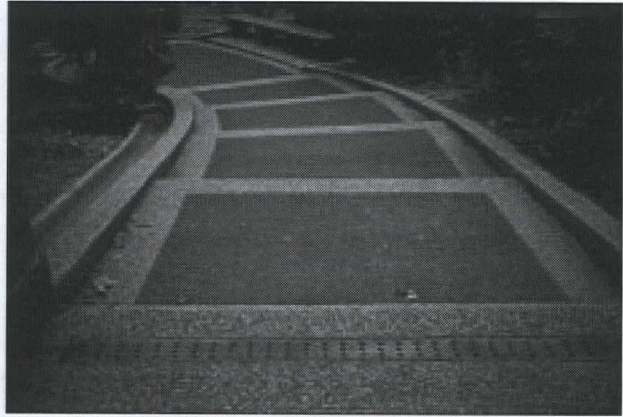
Figure 248: Narrow trench drains captured runoff from walkways, such as the east ascent, 1997. Drain cover visible above is non-original (Land Ethics, Inc.).

The drain inlets, except for the four original inlet covers noted above, have lost their integrity. Almost all of the inlet covers are non-original of several different types and designs. A common replacement cover is thick steel plate with round holes. Other inlets are cast iron, contoured or flat.

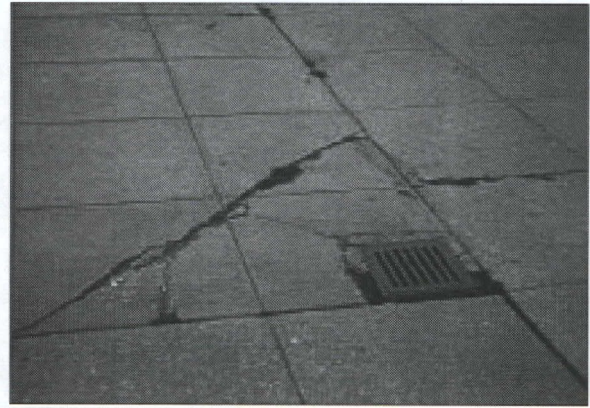
Figure 250: Two small square drain inlets, original locations, are located today in pavement at the triangular sections of paving added after completion of the park. Before addition of the pavement, the original locations of these drains were in the grass, 1977. (Land Ethics, Inc.)

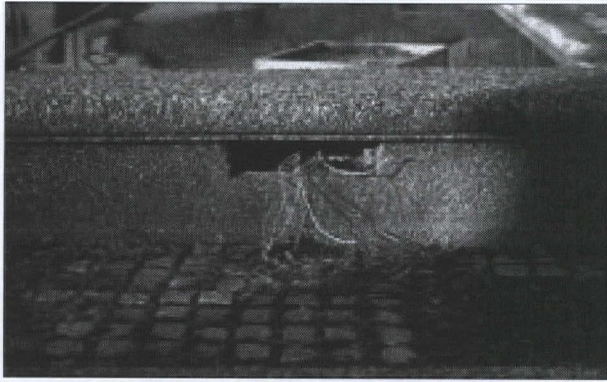
Figure 255: Recessed wall fixture along the edge of the reflecting pool. None of these lights in the lower gardens are presently working, 1996, (Land Ethics, Inc.).

The same cannot be said for the recessed wall lights, none of which is in working order. In 1966, the Cobb and Youseff report estimated that 50% of these fixtures were working.¹⁶ Vandalism and conduit corrosion have taken their toll on these lights, and most are missing lenses and have bare wires exposed to the elements (see plan sheets 38-41). These recessed fixtures, along with the conduit, need to be completely rehabilitated. The light in the chandelier in the 16th Street entrance to the park was in working order at the time of the field survey, and the glass of the chandelier was intact although the fixture is rusted and in need of restoration.

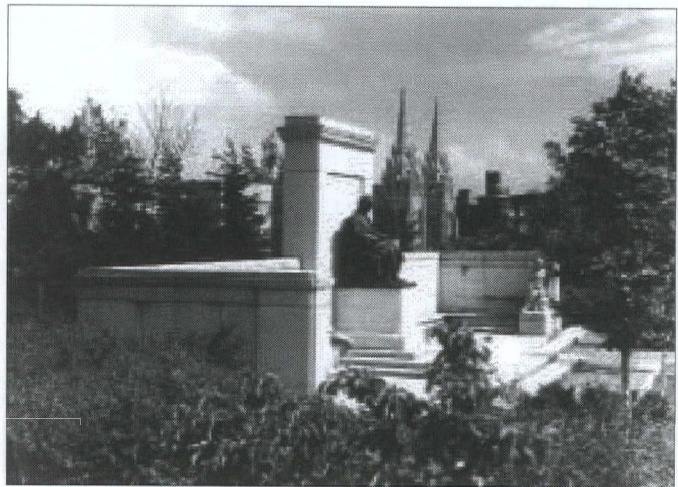
Figure 259: This 1938 view of the memorial to President James Buchanan shows signs of water penetration at the wall cap. (RCP-CRF, June 1938).

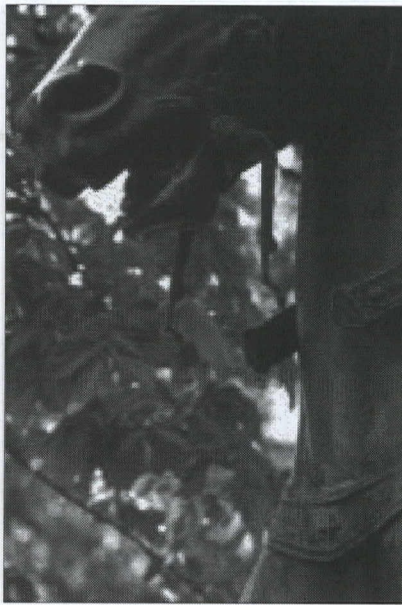
Figure 264: Portions of the statue of Joan of Arc have been vandalized, such as the bridle, 1997 (Land Ethics, Inc.).

Although the Joan of Arc statue is largely intact and in good condition, it does have several broken and missing pieces. The bronze lettering on the base of the sculpture has been vandalized, and many of the letters are bent or missing. The horse is missing a piece of its bridle and has a hairline crack in the left front hoof. The sword from Joan of Arc's right hand is missing, and her belt is broken where it attaches to the scabbard, the bottom part of which is gone.

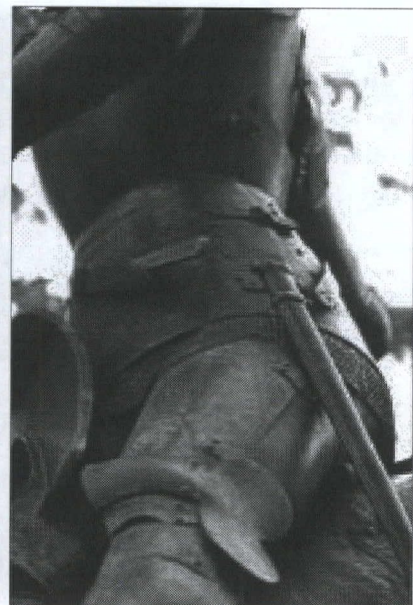
Figure 265: Vandalism to the Joan of Arc statue at the belt where it attaches to the scabbard, 1997 (Land Ethics, Inc.).

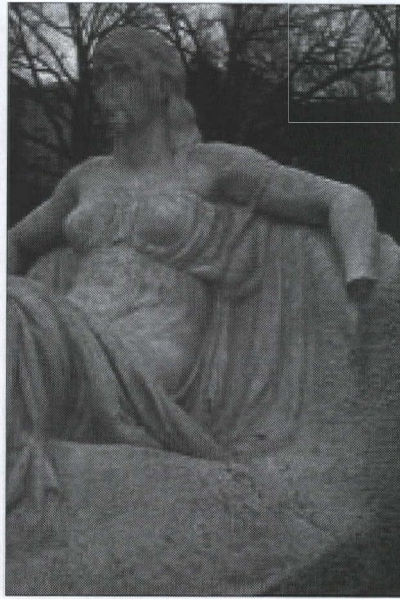
Serenity has been repeatedly vandalized and damaged over the years. The statue's nose and left hand are missing, and there is a hole suggesting the nose may have been previously replaced. Both the left and right big toes are missing, and there are several large cracks in the base of the statue on both the left and right sides. The statue has also been repeatedly defaced with graffiti.

Figure 267: The Serenity statue is in poor condition from vandalism. The nose and left hand are missing. 1997 (Land Ethics, Inc.).

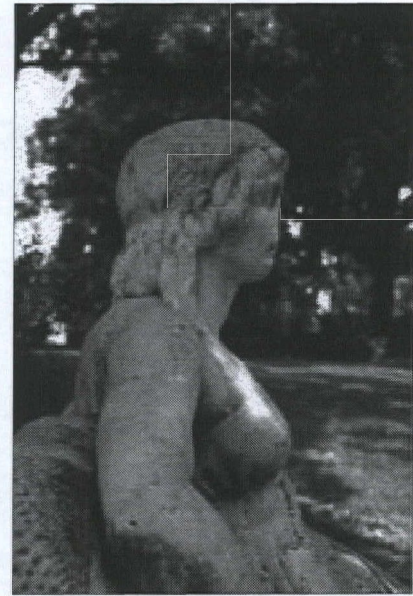
Figure 268: Additional detail of damage inflicted by vandals on the statue of Serenity, 1996 (Land Ethics, Inc.).
